## Motor and drive tests keep lift station running during upgrade

### Application Note

### Testing Functions Case Study

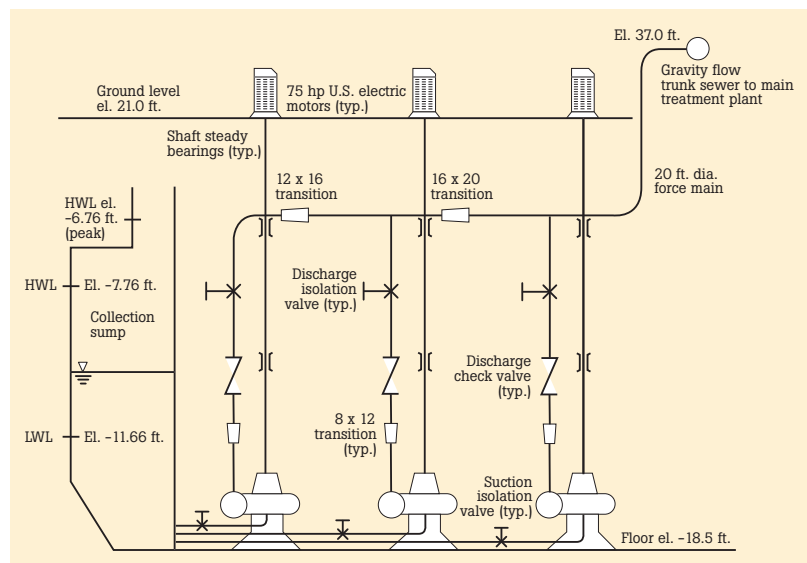
The pump station under test included wet wells, pumps, motors, and drives.

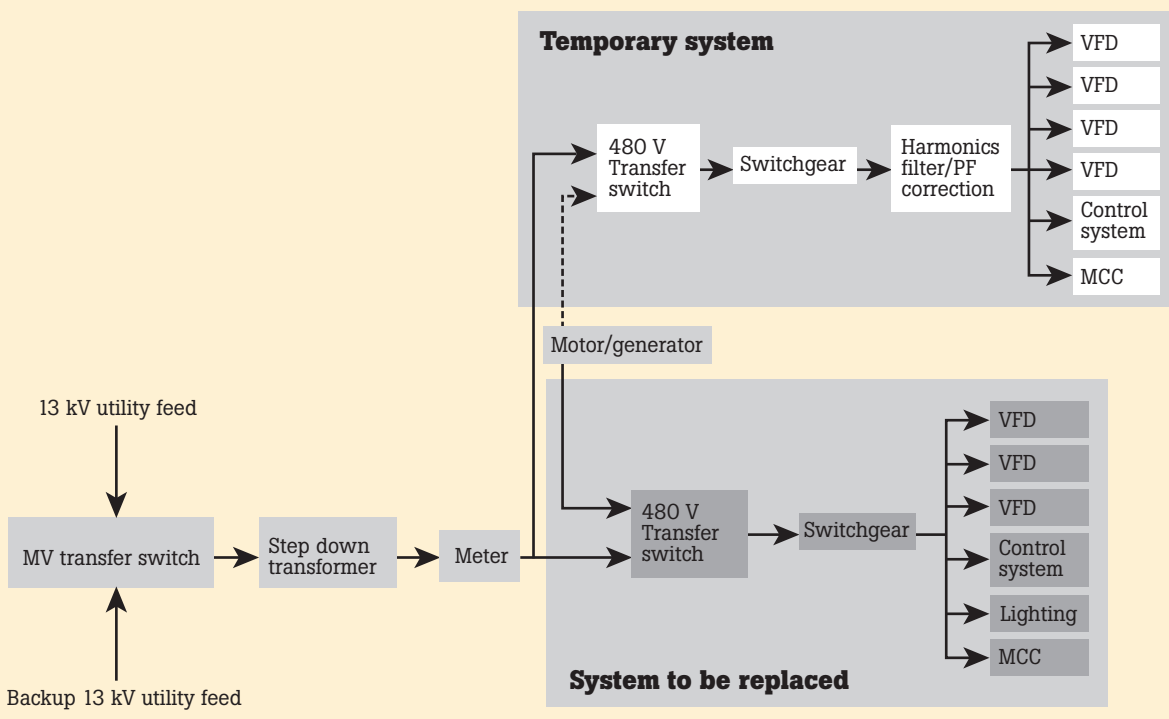
Key elements of the duplicate electrical system.

Valley Electric Company of Everett, WA was awarded the contract to retrofit the electrical systems in the lift station. The station runs 24 hours a day, seven days a week, so bringing it down was not an option. So, Valley built a duplicate electrical system in a modular structure next to the pump house. The temporary system includes switchgear, MCC's, variable frequency drives, transfer switch, surge suppression, and harmonics and PF correction. The modular structure also houses a duplicate control system that will take input from existing sensors and control the pumps. After this temporary system is used for this pump station, the plan is to lift it by crane and move it onto the next retrofit.

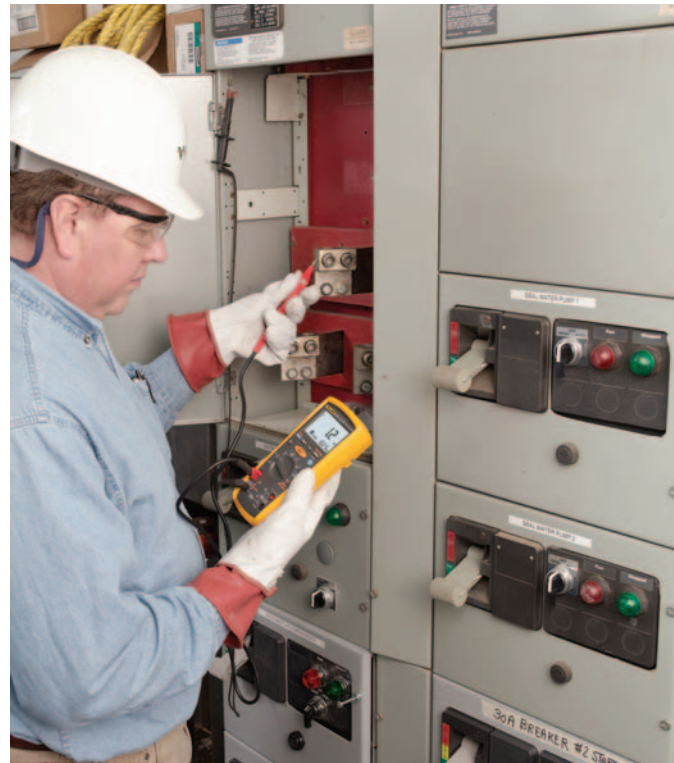
Steve Uhrich tests resistance of drive cabling.

Prior to connecting the new system to utility power, Uhrich and Glazier tested the incoming cabling and switchgear. The 1000 volt insulation testing and continuity functions of the 1587 were used during this initial testing. They insulation-tested each of the conductors to ground and to each other. During this phase of testing they found that one of the phase conductors from the fused disconnect, feeding the temporary switchgear, had only 400 k ohms resistance to ground. It should have been at least in the megohms. They replaced the cable before proceeding.
