Fluke instruments add reliability to oceanographic research

Application Note

Testing Functions Case Study

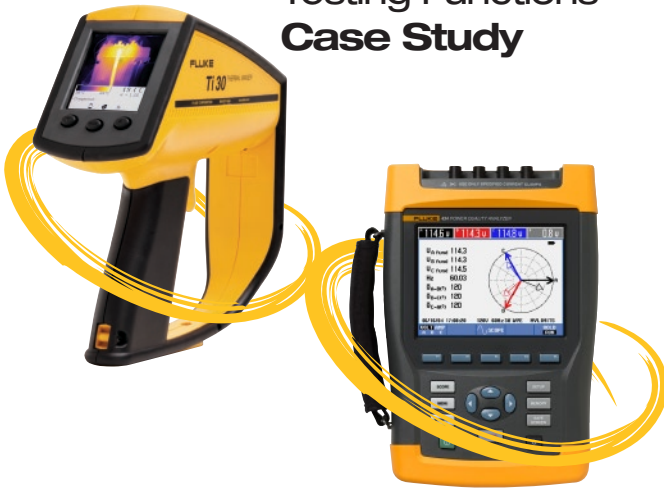
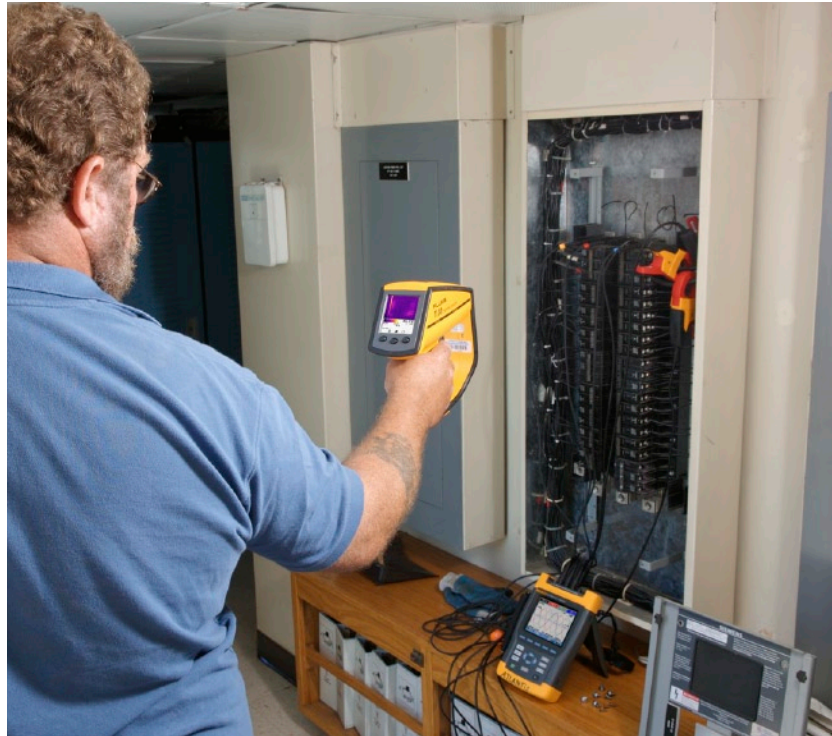
The Fluke 434 Power Quality Analyzer measures and stores power quality factors for troubleshooting or for trending over time.

The Fluke Ti30 Thermal Imager records the surface temperatures of objects and displays them as thermal images that reveal abnormal hotspots. Since electrical problems often cause an increase in temperature. If one component appears hotter than others, there could be a problem.

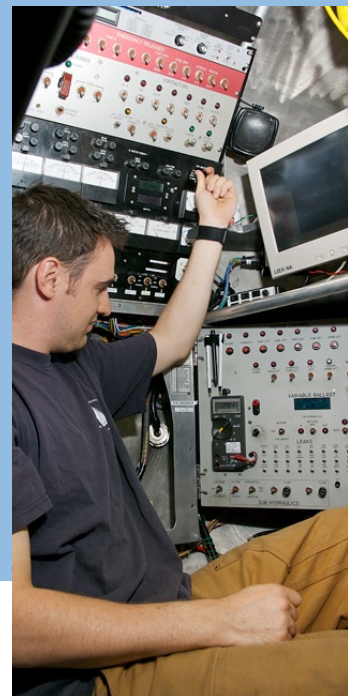
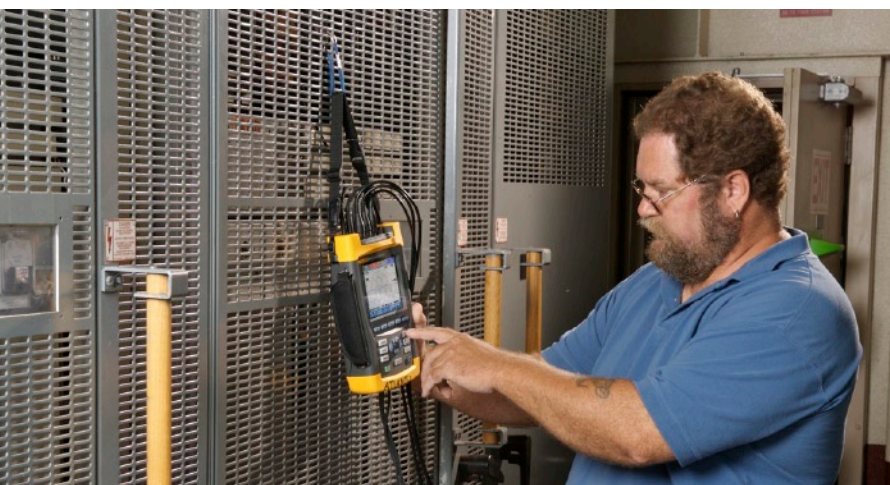
Alvin is a U.S. Navy-owned, WHOI-operated, human-occupied deep submergence research vehicle capable of taking two research scientists and a pilot to ocean depths of 4,500 meters (about three miles). While diving and surfacing is accomplished by gravity and buoyancy using water ballast and expendable steel weights, the submersible relies on six battery-powered, reversible thrusters to hover and maneuver.

Safety and operational considerations make it essential to monitor the Alvin's battery array, and WHOI has selected a Fluke digital multimeter to do the job. The meter serves as a permanently mounted voltmeter that constantly monitors the state of the batteries in the submersible's battery compartment.
